**Flood Control Project Maintenance
Levee Inspections**

Fall 2018 Levee Maintenance Deficiency Summary Report

San Joaquin River Basin

Reclamation District No. 2075 McMullin

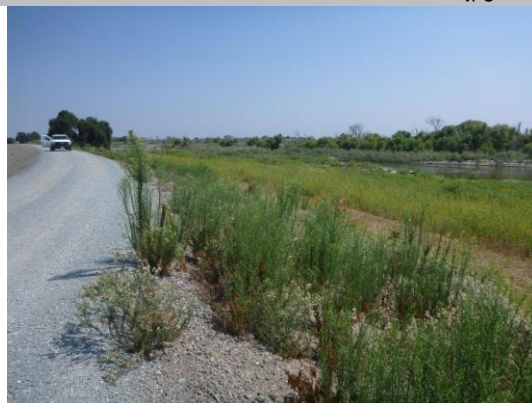
Photo 3 of 3 : LEVAL_FA_2018_577_4475.jpg

LM Start	4.00	Rating **	A/W	Issue No.	19 (cont)
LM End	4.04	Issue Type +	Ma	Location *	WS
Category	Supplemental			GPS Latitude/Longitude	
				Start	End
Item	2017 Storm Damage			37.714048 °	37.714630 °
				-121.278363 °	-121.278263 °
DWR ID	DWR_RD2075_01_f_2017_19				
Comment Code					
Inspector Comment					
Levee Evaluation Comments					
Description:Slope protection repairs are needed along the waterside slope due to erosion and riprap displacement from high water. Based upon levee inspections, it was determined the waterside levee slope is eroding, deteriorating, and degrading. The eroded levee sections need to be restored back to design standards to prevent further deterioration and damage.					
Site ID No:577					
Site Designation:LMA-483					
Repair Type: Erosion					
Rating:Area of Concern					
Field Date:8/10/2017					
Notes:

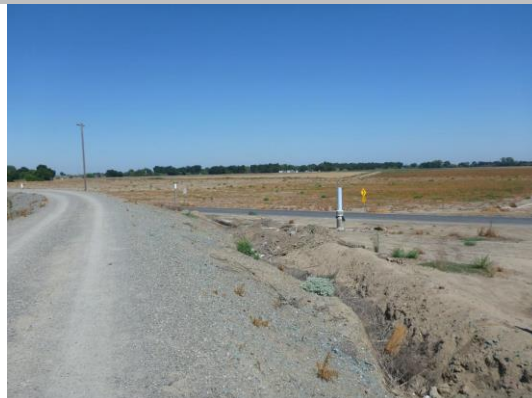
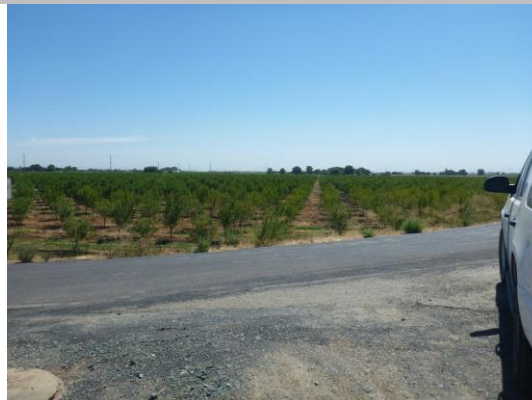
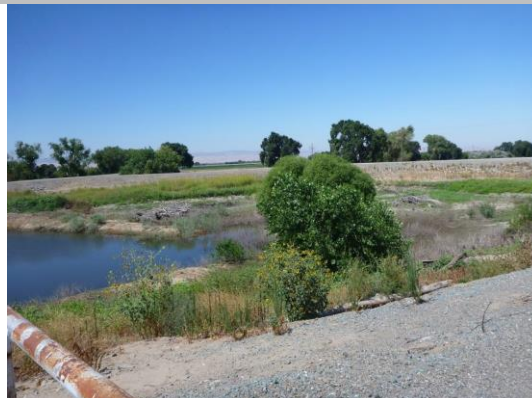
LM Start	4.95	Rating **	A/W	Issue No.	20
LM End	5.20	Issue Type +	Ob	Location *	LS
Category	Supplemental			GPS Latitude/Longitude	
				Start	End
Item	2017 Storm Damage			37.727200 °	37.728900 °
				-121.277800 °	-121.275200 °
DWR ID	DWR_RD2075_01_f_2017_20				
Comment Code					
Inspector Comment					
Levee Evaluation Comments					
Description:Heavy seepage was observed during the high water this year 2017.					
Site ID No:481					
Site Designation:LMA-308					
Repair Type: Seepage					
Rating:Area of Concern					
Field Date:7/26/2017					
Notes: No evidence of flood fight here, but the orchard trees next to the levee are looking a little yellow compared to the others.

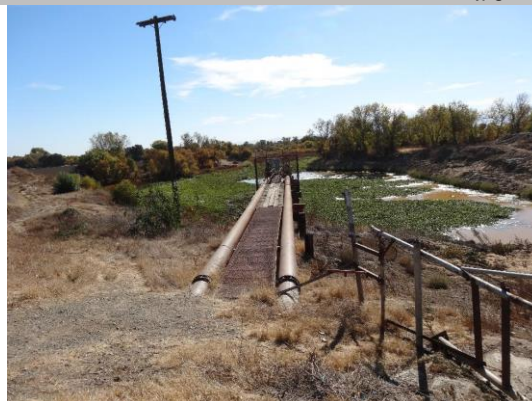
Photo 1 of 3 : UCIP_FA_2018_50209_45603.jpg

Comment Code						
Inspector Comment						
FS_ID:50209 DS_ID:24739 EP_NO: N/A Repair Type: Non-Urgent Crossing Status: Found UCIP Comments: - flap gates in concrete box on LS toe have failed and are open. Rusted through flapgate may indicate condition of interior of pipe. FIELD_STRUCT_DESC: 1 of 2: 16-inch steel irrigation discharge pipe through the levee, 8 feet below the crown. Electrical conduit through the levee. Pump mounted on a pile structure in the river. Wooden walkway to the pump. Siphon breaker and concrete distribution box on the landside (LS) slope. [Additional Reference(s): DWR Levee Log, 2005, 18-inch pipe referenced. USACE San Joaquin O&M Manual 3, December 1968, (HLM 5.16), 18-inch pipe referenced]. FS Date: 6/21/2016

WS view: two pipes, walkway to pump and pile structure in the stream.

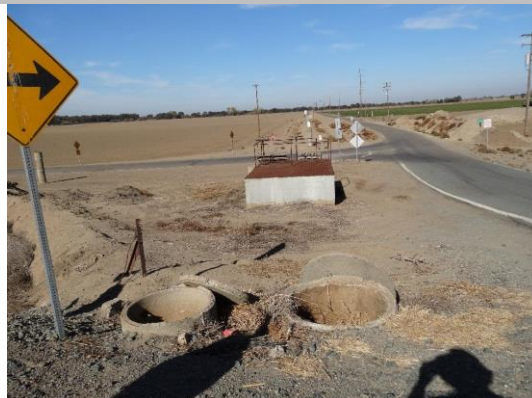
Photo 2 of 3 : UCIP_FA_2018_50209_45602.jpg

Comment Code						
Inspector Comment						
FS_ID:50209 DS_ID:24739 EP_NO: N/A Repair Type: Non-Urgent Crossing Status: Found UCIP Comments: - flap gates in concrete box on LS toe have failed and are open. Rusted through flapgate may indicate condition of interior of pipe. FIELD_STRUCT_DESC: 1 of 2: 16-inch steel irrigation discharge pipe through the levee, 8 feet below the crown. Electrical conduit through the levee. Pump mounted on a pile structure in the river. Wooden walkway to the pump. Siphon breaker and concrete distribution box on the landside (LS) slope. [Additional Reference(s): DWR Levee Log, 2005, 18-inch pipe referenced. USACE San Joaquin O&M Manual 3, December 1968, (HLM 5.16), 18-inch pipe referenced]. FS Date: 6/21/2016

LS view: siphon breakers in concrete pipe risers (bottom) on levee slope. Concrete distribution box on levee toe (top).

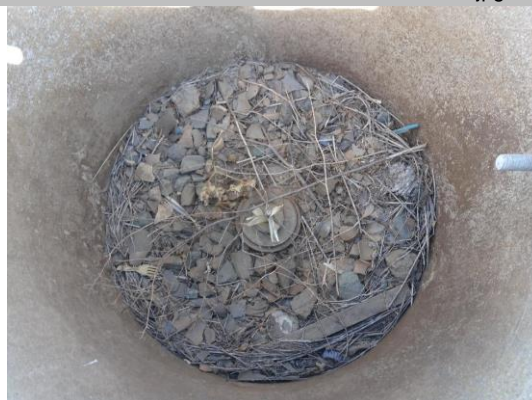
Photo 3 of 3 : UCIP_FA_2018_50209_45605.jpg

LS view: siphon breaker in concrete pipe riser on levee slope.

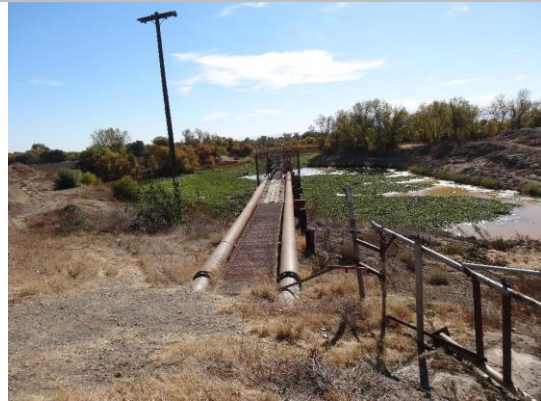
Photo 1 of 3 : UCIP_FA_2018_25184_45608.jpg

LM Start	5.20	Rating **	M	Issue No.	35	
LM End	5.20	Issue Type +	En	Location *		
Category	Supplemental			GPS Latitude/Longitude		
				Start	End	
Item	DWR UCIP Field Study			37.728848 °	37.728848 °	
				-121.275195 °	-121.275195 °	
DWR ID	24743					
Comment Code						
Inspector Comment						
FS_ID:25184 DS_ID:24743 EP_NO: N/A Repair Type: Non-Urgent Crossing Status: Found UCIP Comments: Flap gate lid displaced. FIELD_STRUCT_DESC: 2 of 2: 16-inch steel irrigation discharge pipe through the levee, 8 feet below the crown. Electrical conduit through the levee. Pump mounted on a pile structure in the river. Wooden walkway to the pump. Siphon breaker and concrete distribution box on the landside (LS) slope. [Additional Reference(s): DWR Levee Log, 2005, 18-inch pipe referenced. USACE San Joaquin O&M Manual 3, December 1968, (HLM 5.16), 18-inch pipe referenced]. FS Date: 11/13/2013

WS view: two pipes, walkway to pump and pile structure in the stream.

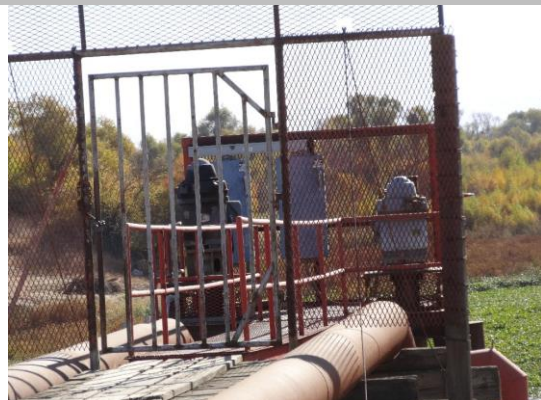
Photo 2 of 3 : UCIP_FA_2018_25184_45607.jpg

WS view: closer view of two pumps and platform in the stream.

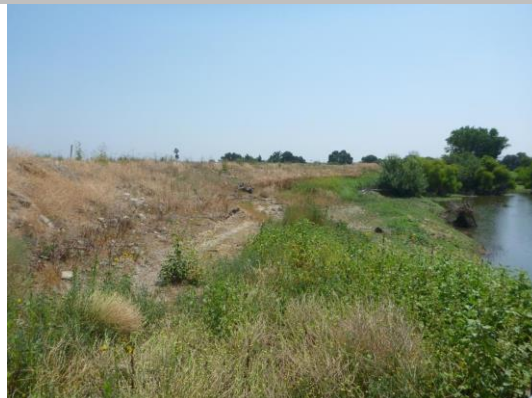
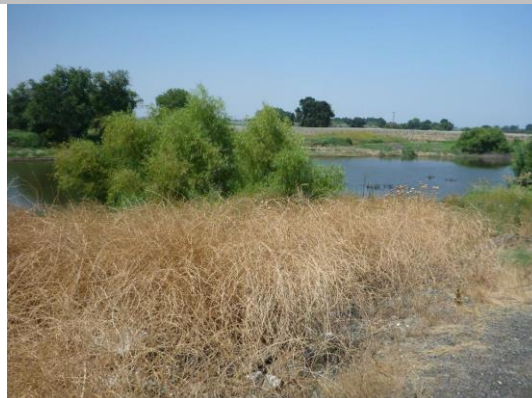
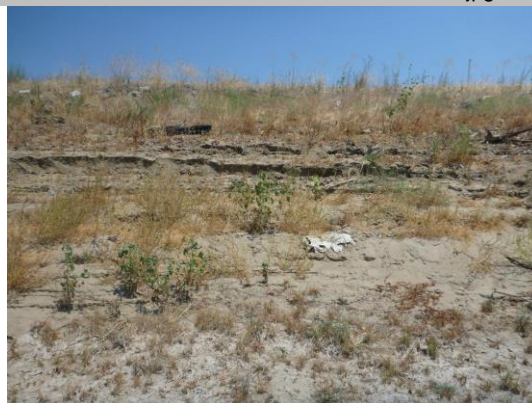
LM Start	5.24	Rating **	A/W	Issue No.	21
LM End	5.29	Issue Type +	Ma	Location *	WS
Category	Supplemental			GPS Latitude/Longitude	
				Start	End
Item	2017 Storm Damage			37.728460 °	37.727799 °
				-121.274671 °	-121.274252 °
DWR ID	DWR_RD2075_01_f_2017_21				
Comment Code					
Inspector Comment					
Levee Evaluation Comments Description: Slope protection repairs are needed along the waterside slope due to erosion and riprap displacement from high water. Based upon levee inspections, it was determined the waterside levee slope is eroding, deteriorating, and degrading. The eroded levee sections need to be restored back to design standards to prevent further deterioration and damage. Site ID No: 578 Site Designation: LMA-484 Repair Type: Erosion Rating: Area of Concern Field Date: 8/10/2017 Notes: Paved road on levee.
